Preliminary Report on the Performance of the New Orleans Levee Systems in Hurricane Katrina on August 29, 2005

Preliminary findings from field investigations and associated studies performed by teams from the University of California at Berkeley and the American Society of Civil Engineers, as well as a number of cooperating engineers and scientists, shortly after the hurricane.

Report No. UCB/CITRIS – 05/01
November 2, 2005

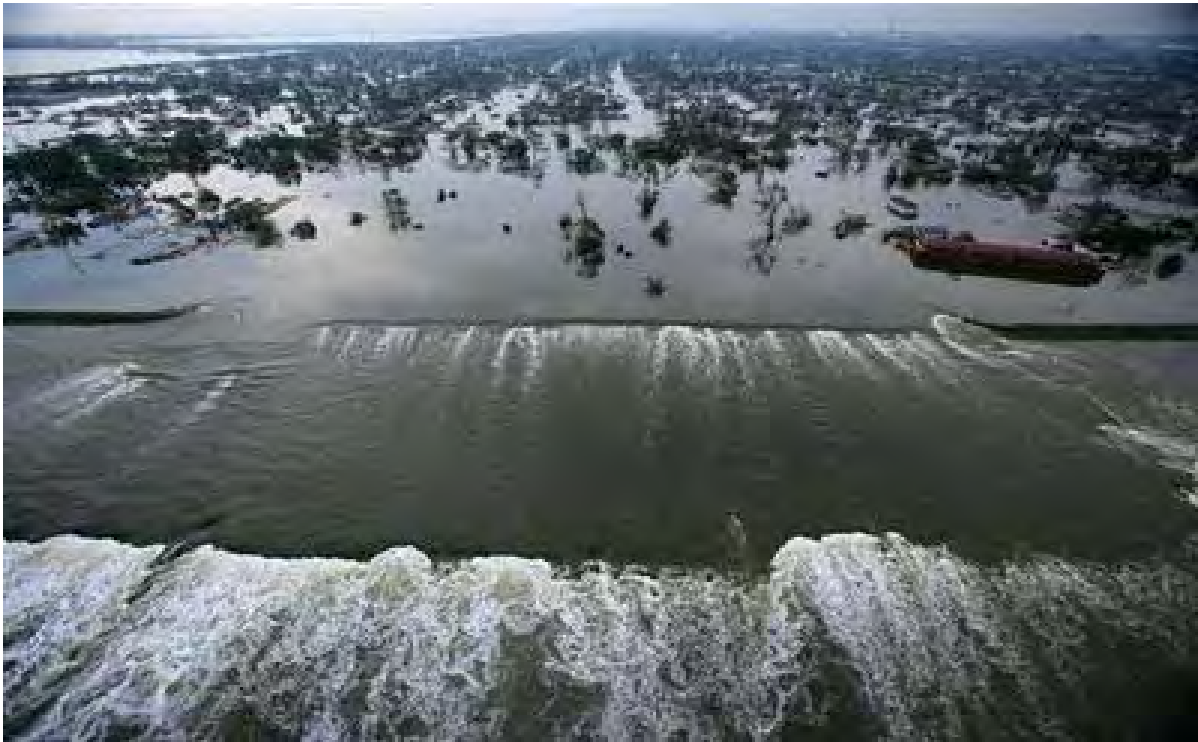
The consequences of the flooding of major portions of all four levee-protected polders were catastrophic. Figure 1.7 shows inundation of the Ninth Ward adjacent to one of the major breaches in the levee along the IHNC. Numerous areas of greater New Orleans were similarly flooded, as shown in Figures 1.4 and 1.5. Large developed areas within all of the main polders were flooded, and they remained inundated for considerable periods of time before levee breaches could be repaired and the waters pumped out.

Figure 1.7: Flooding at the west end of the Ninth Ward, and outflow through levee breach as initial storm surge subsides.

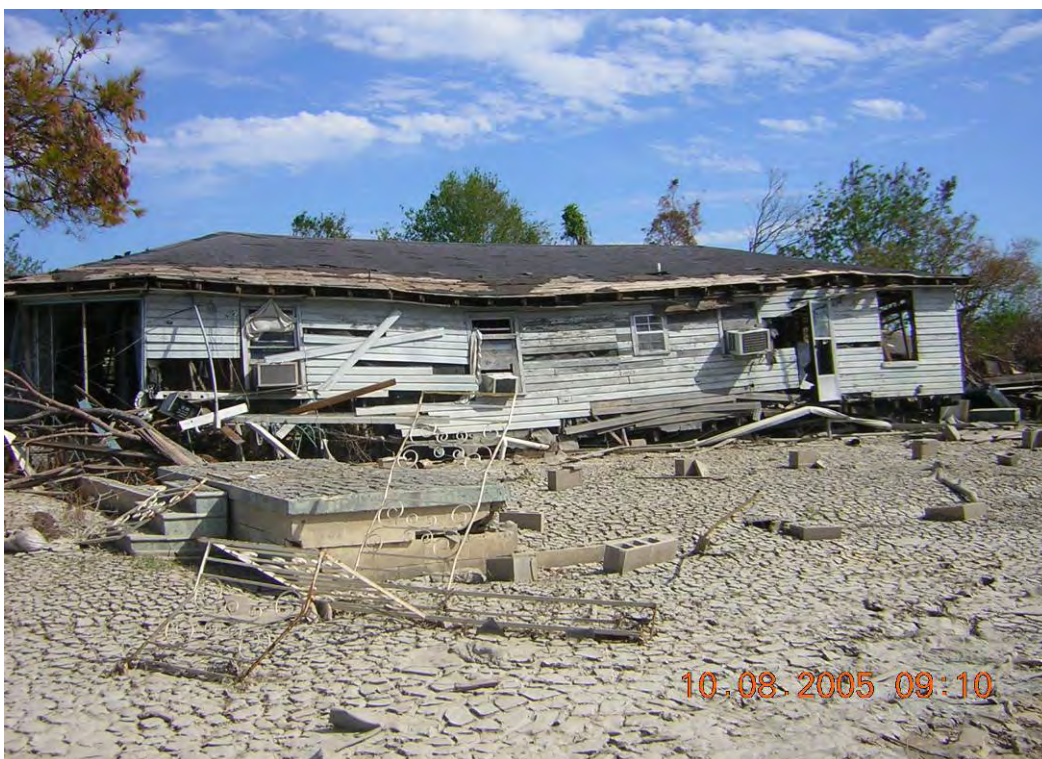
Figure 1.13: Another view of flooding damage, this time in the lower Ninth Ward.

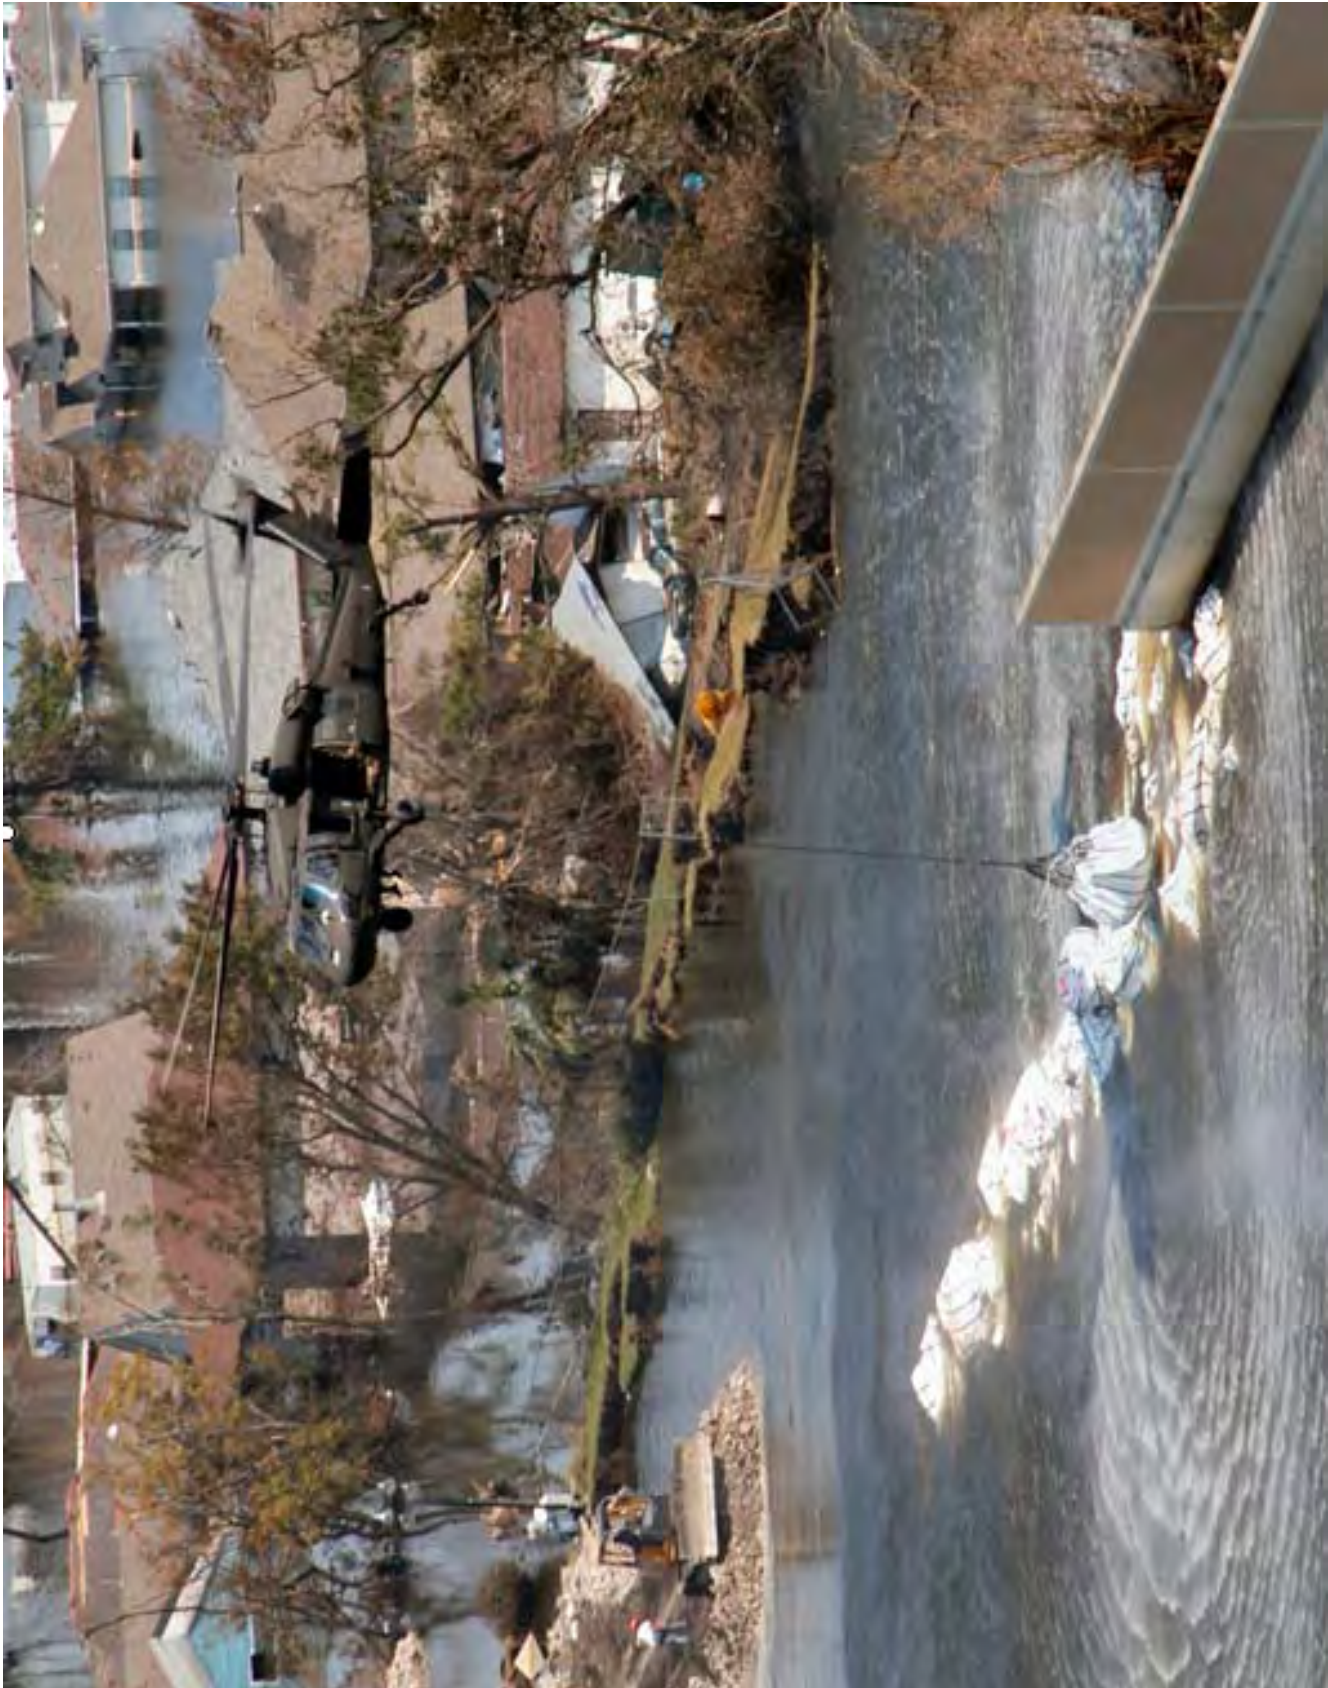
Figure 2.3(a): The 17th Street Canal breach during initial breach closure.

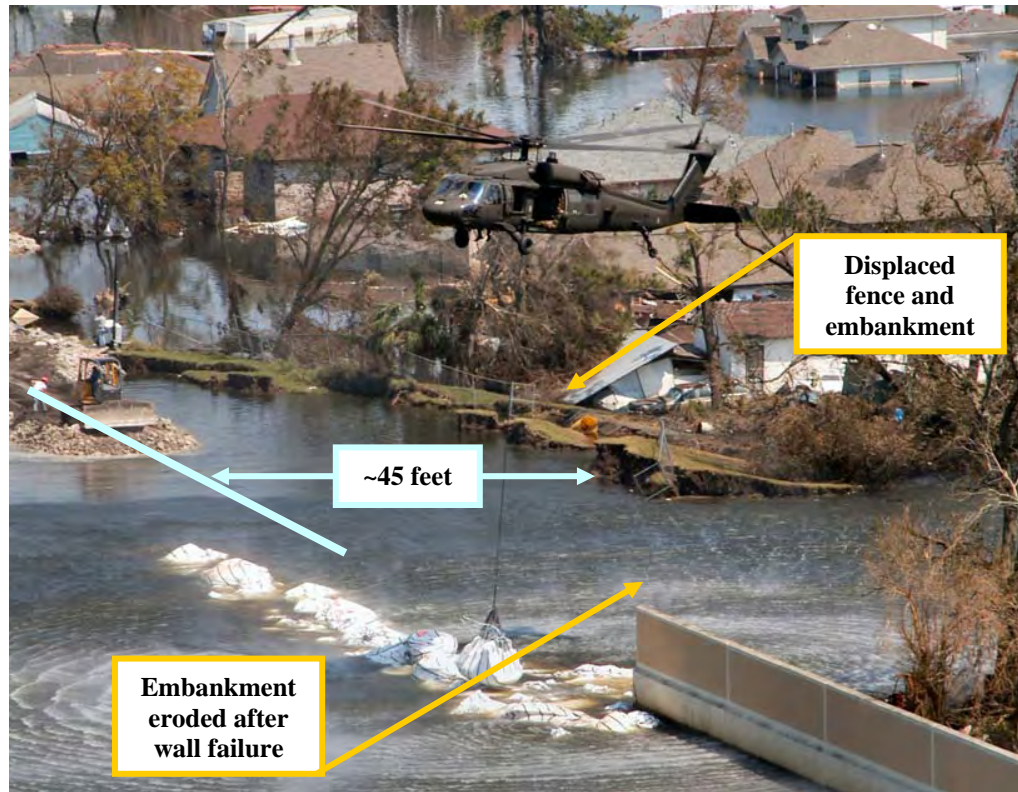
Figure 2.3(b): The 17th Street breach, highlighting key points for discussion

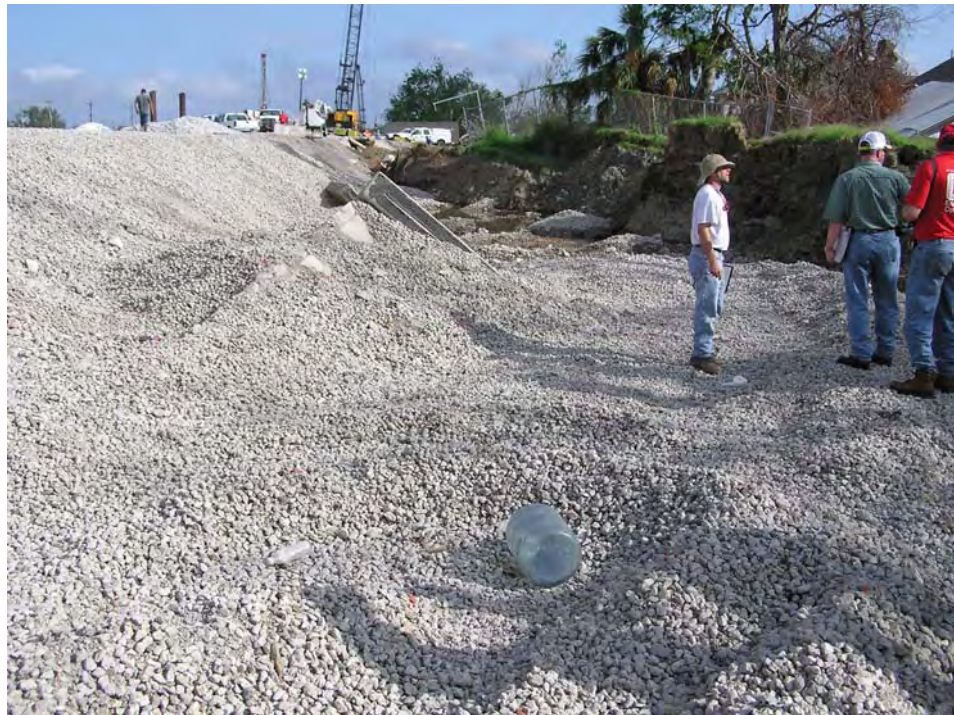
Figure 2.4: View of the 17th Street breach section from the south.

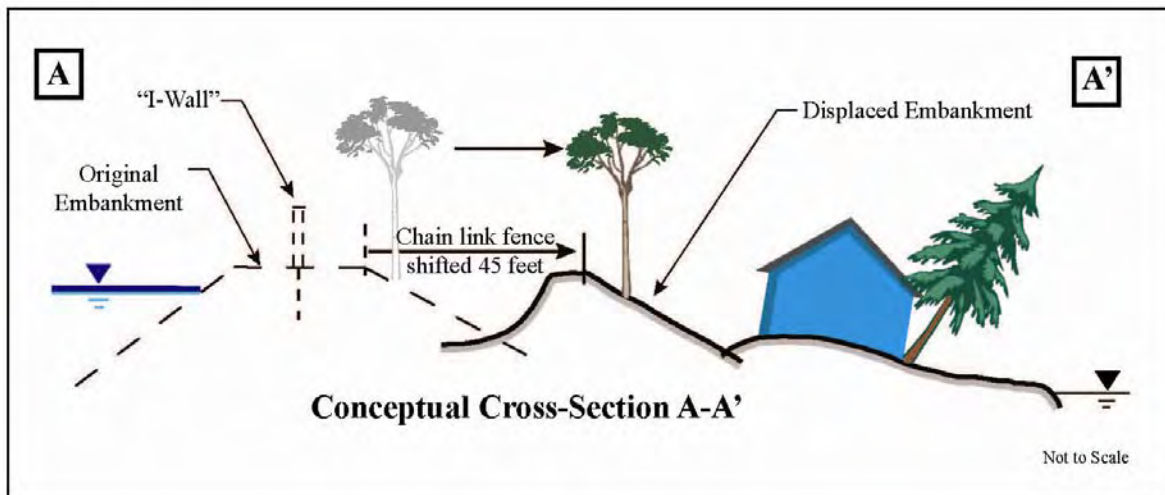
Figure 2.7: Schematic cross section at the 17th Street breach section.

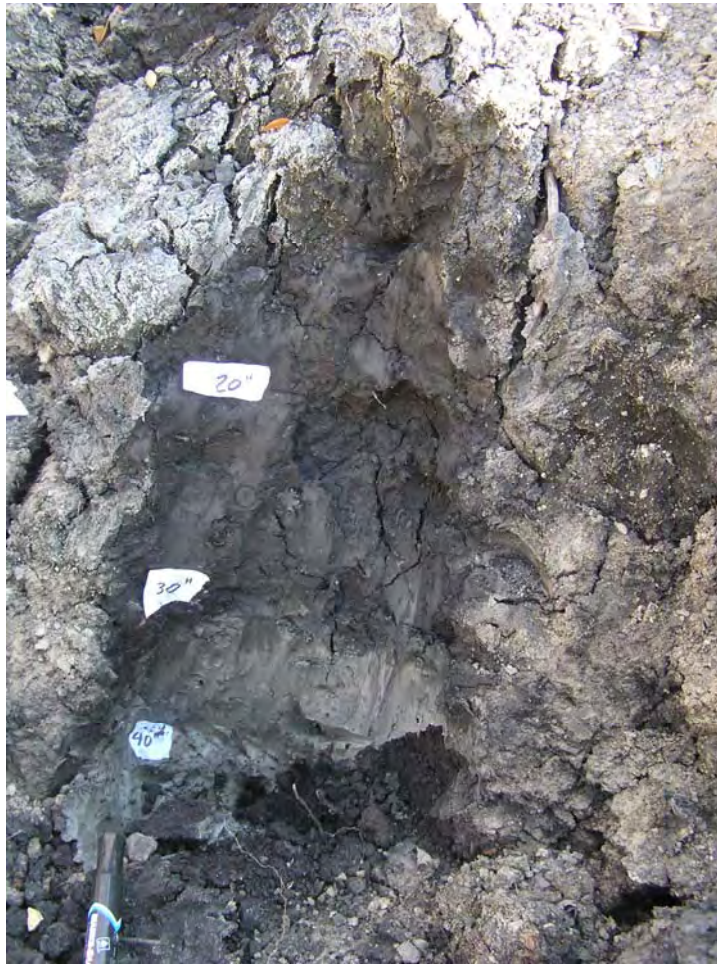
Figure 2.9: Clay seam (light gray layer) underlain by darker lean clay, and overlain by fibrous peat.

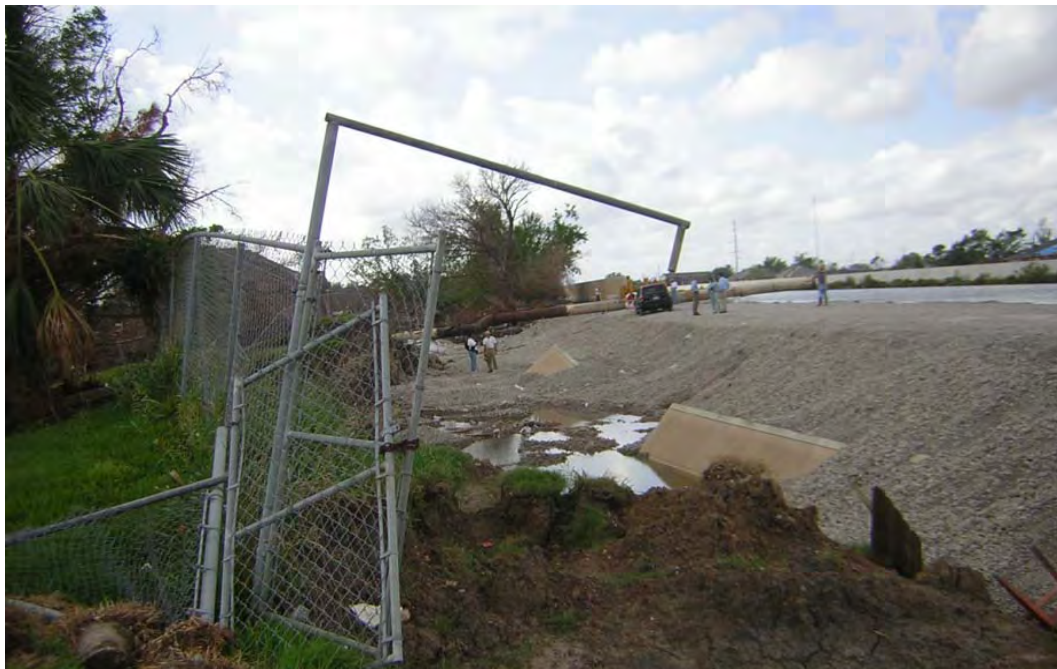
Figure 2.12: Temporary closure section embankment on October 3rd, 2005.

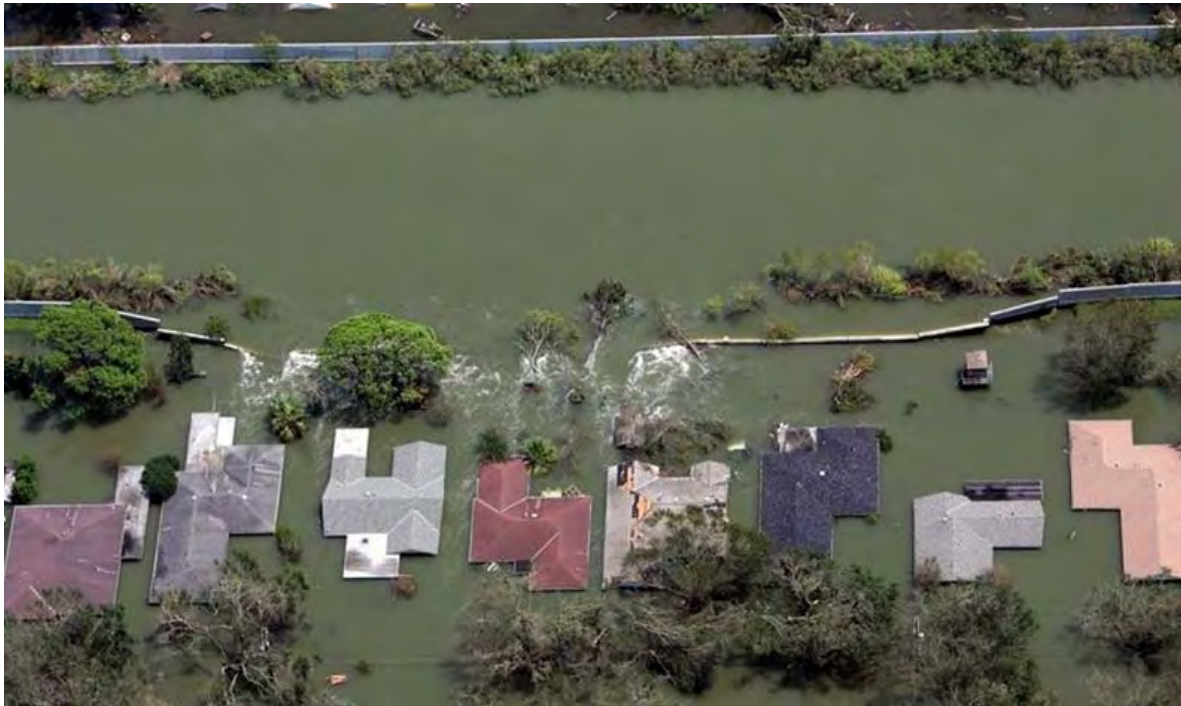
Figure 2.15: The breach section at the west side of the London Avenue Canal (North).

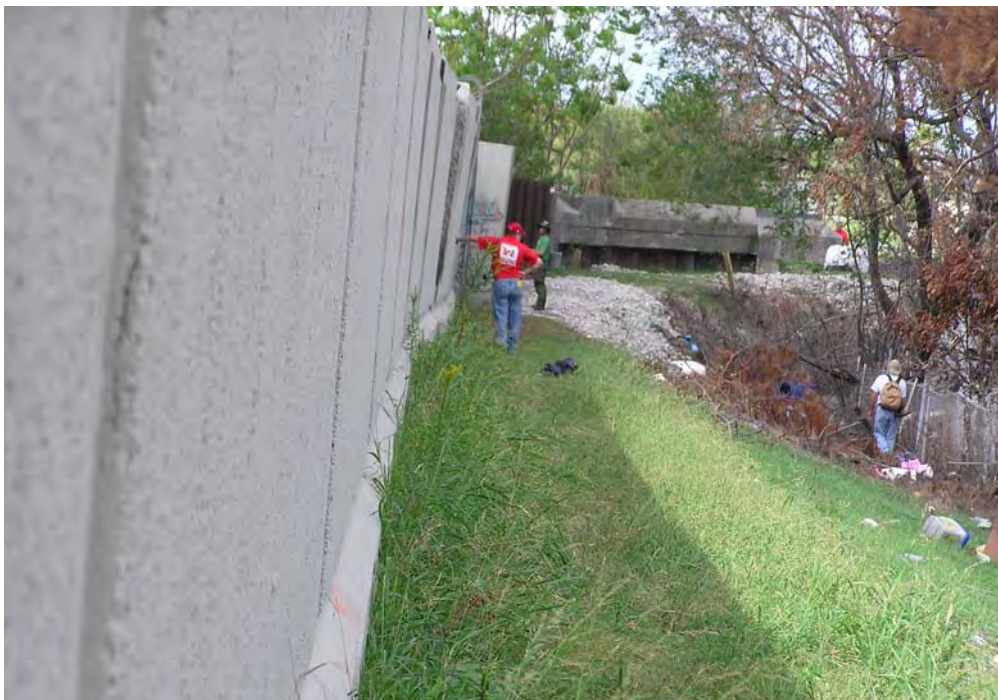
Figure 2.20: View of the inboard side of the floodwall and earthen levee embankment.

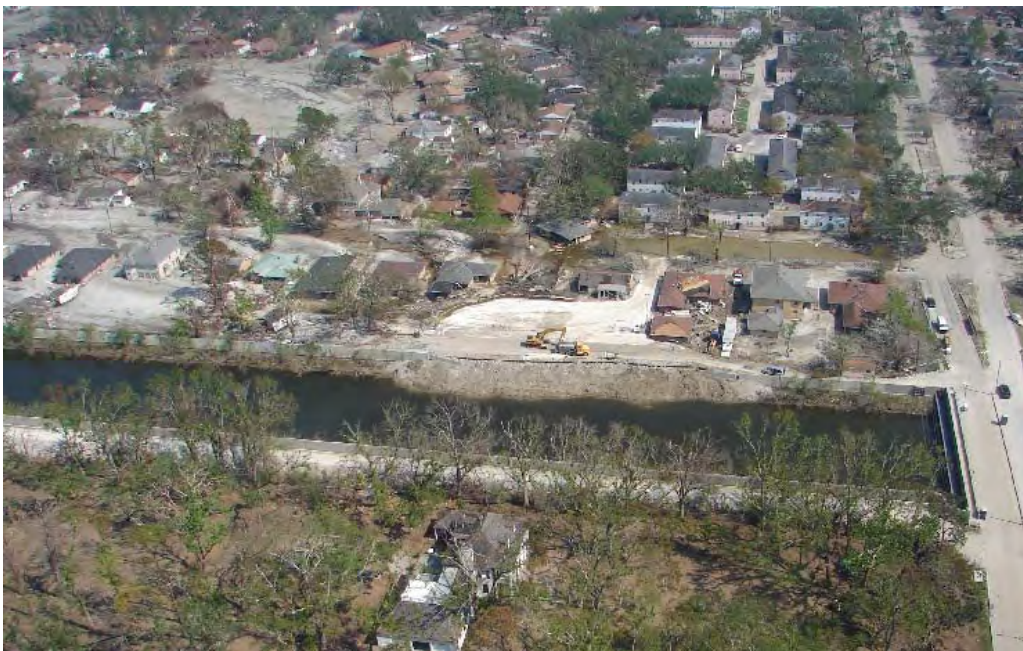
Figure 2.24: Aerial view of the breach section at London Avenue Canal (South).

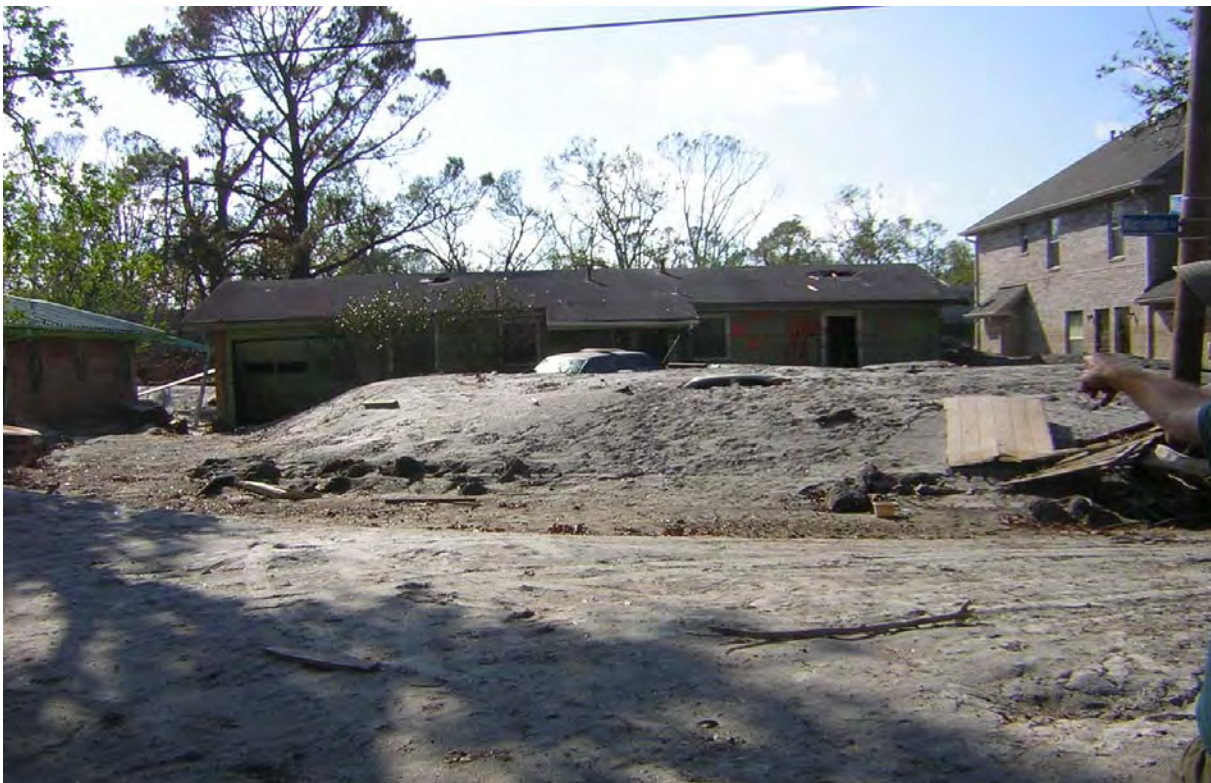
Figure 2.26: Significant quantities of sediment were deposited in the residential neighborhoods on the east side of the London Avenue Canal. More than five feet of sediment was deposited around this home.

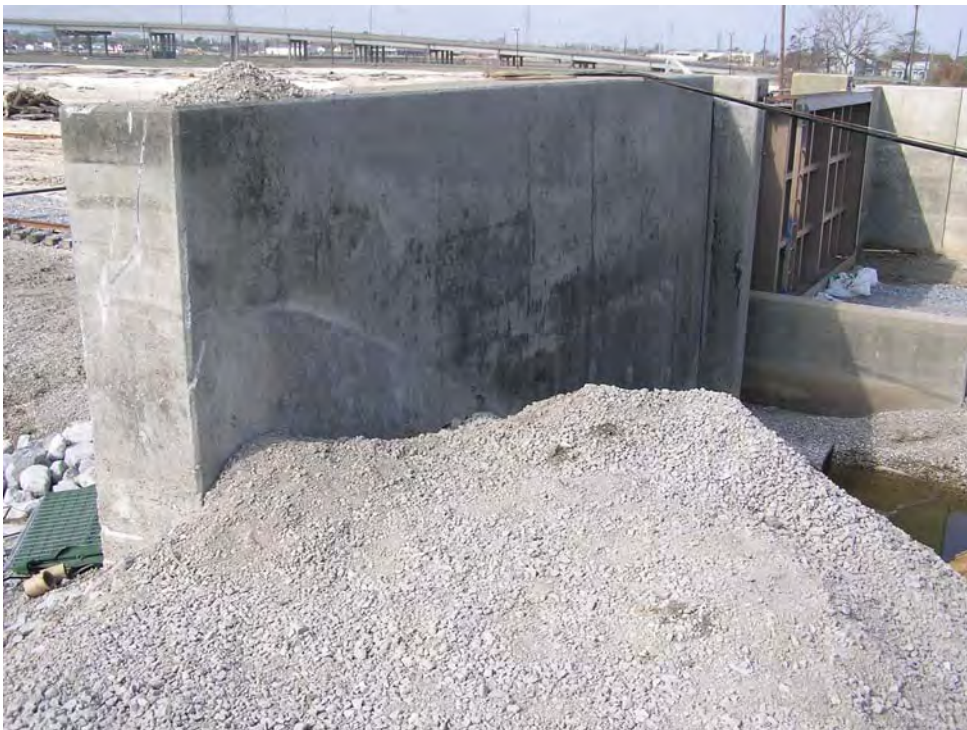
Figure 2.30: View of the structural wall and floodgate structure from Figure 2.29.

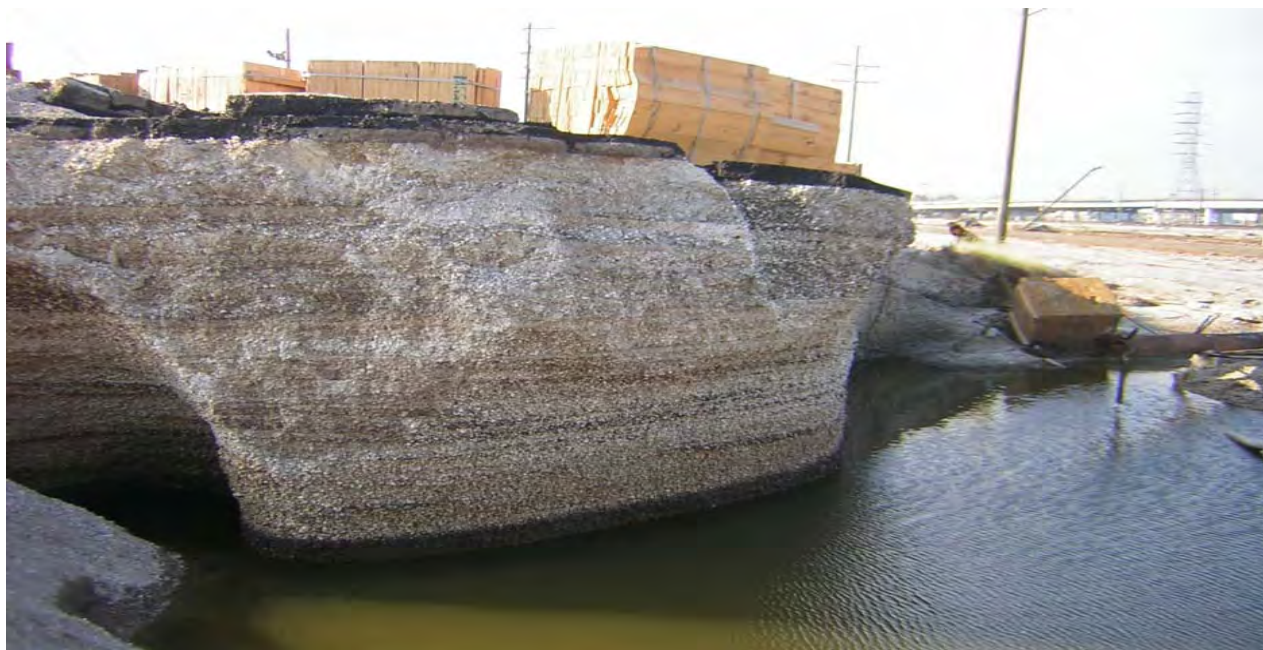
Figure 2.32: Closeup view of sandy “shell” fill at the scoured edge of the breach shown previously in Figure 2.31.

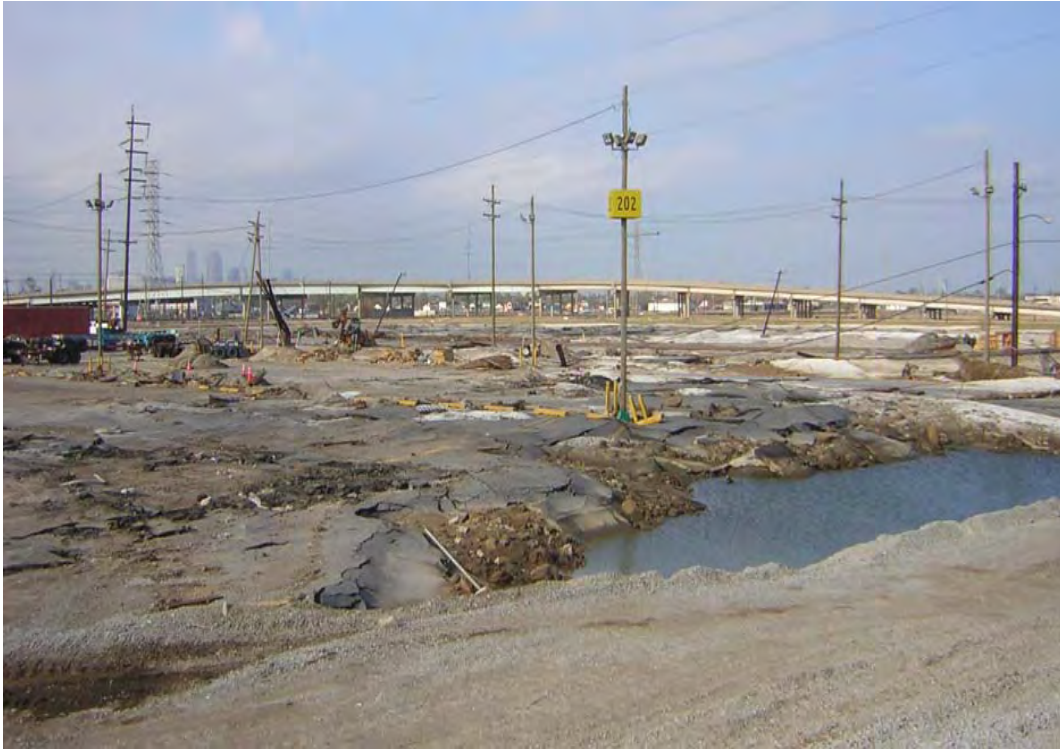
Figure 2.33: Flooding, and deposits of sediment and shells, inboard of the breach shown previously in Figure 2.32.

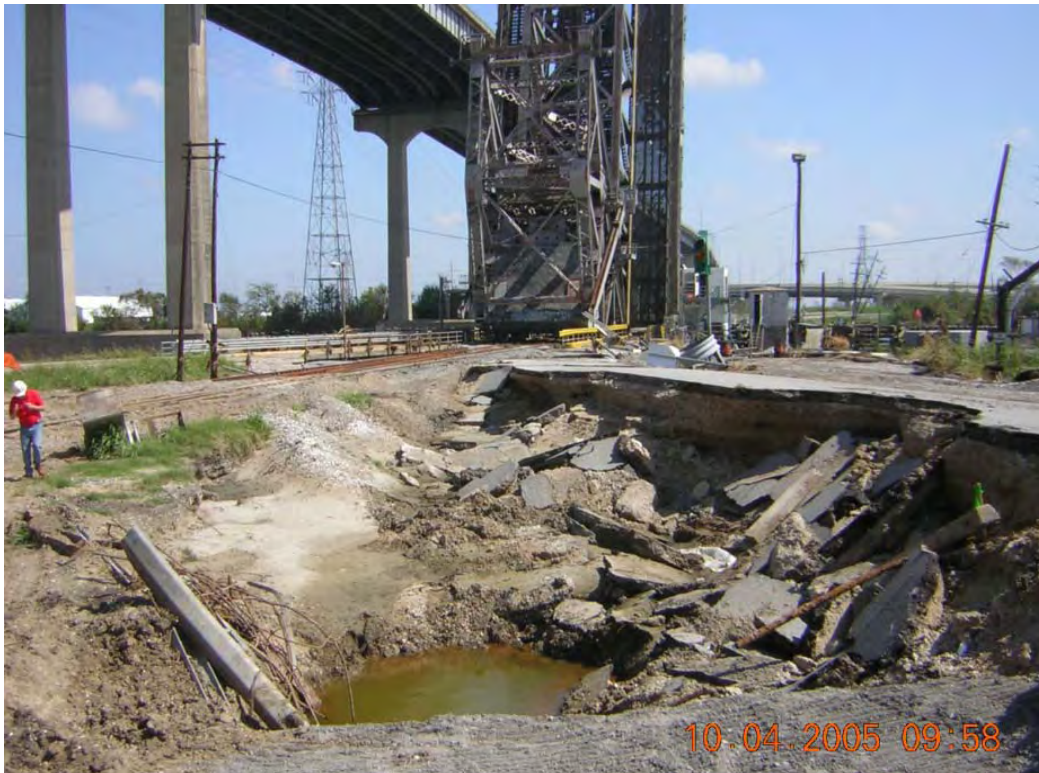
Figure 2.34: A complex “transition” involving several overlapping operations and penetrations through the flood protection levees immediately south of the I-10 bridge across the IHNC.

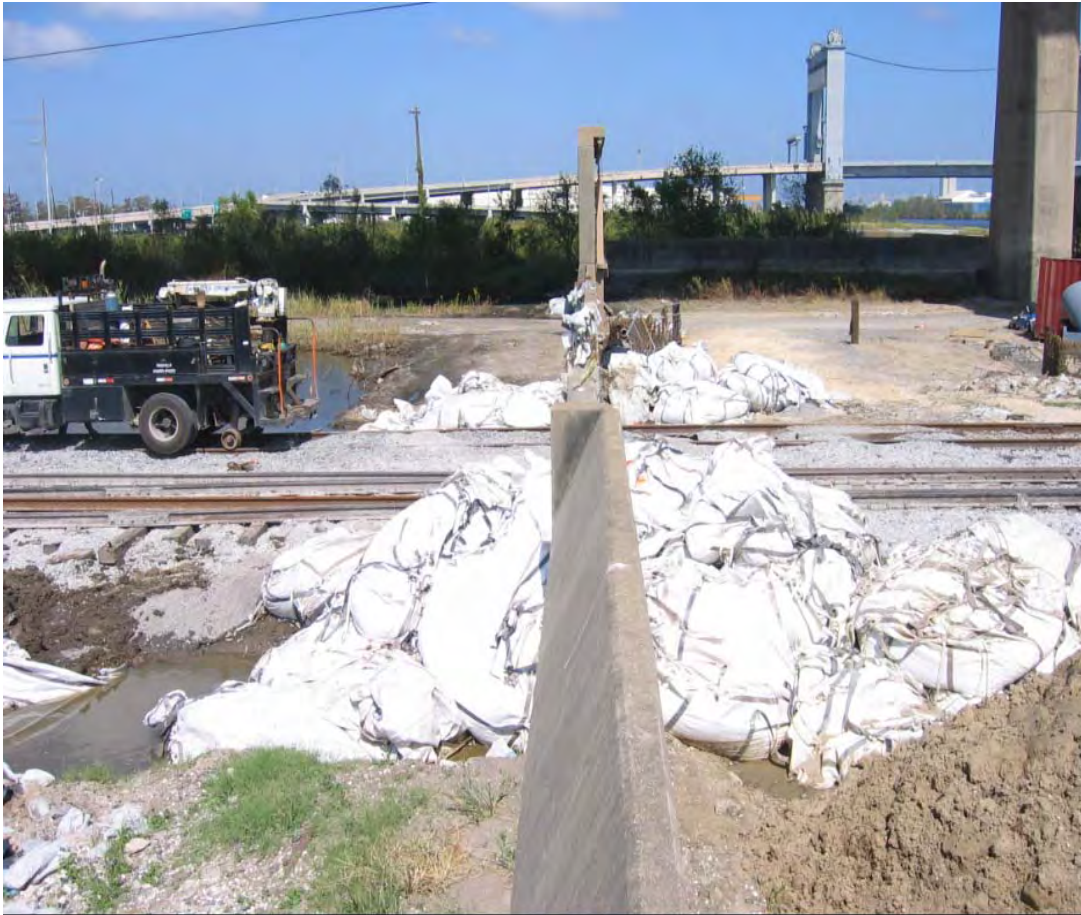
Figure 2.35: Rail line crossing through floodgate structure at the west side of the INHC at the complex transition shown in Figure 2.34.

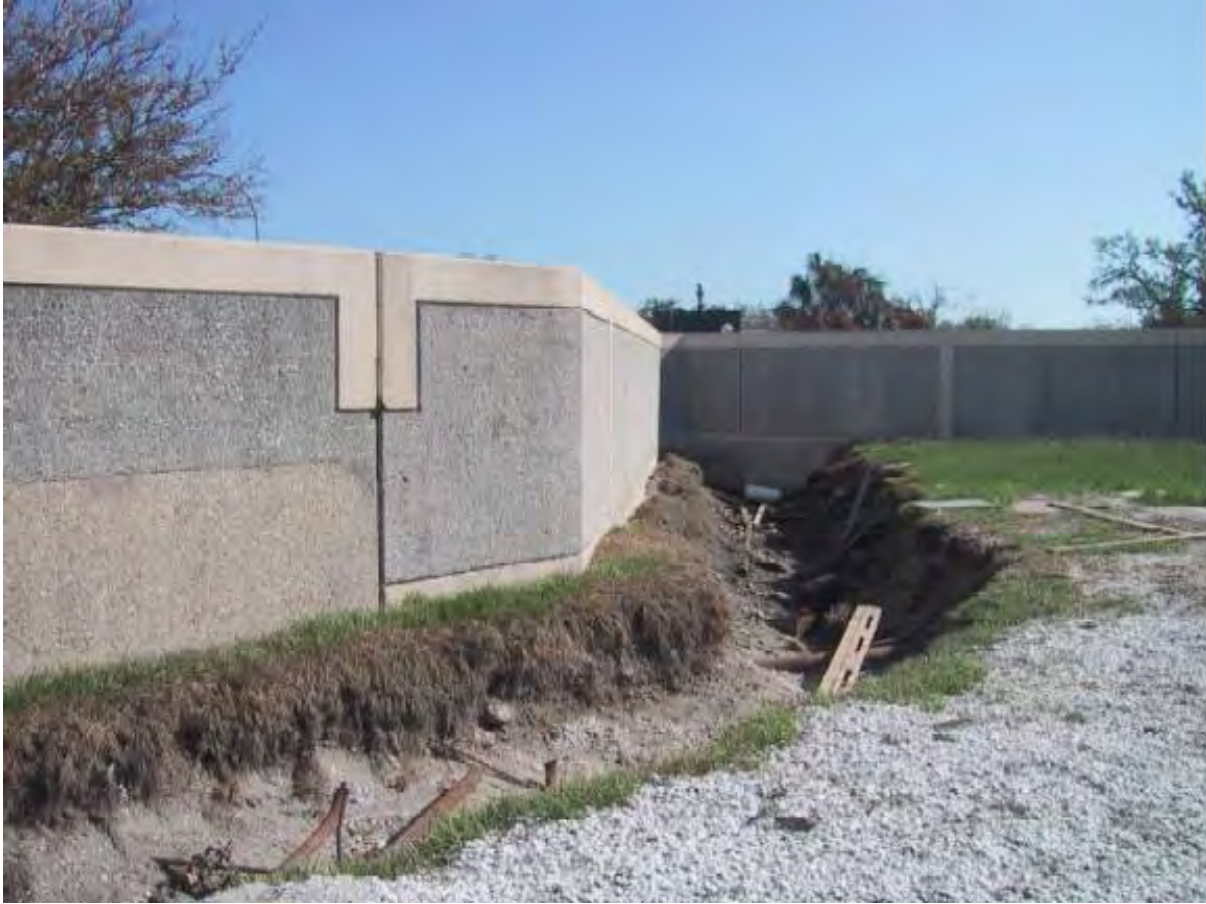
I-wall sections on the lakefront side appeared to have been slightly overtopped (or at least experienced significant splash over) as evidenced by scour of the soil on the protected side of the walls and debris both on and behind the walls. Inspection of these wall sections showed little to no distress despite the significant scouring at places (Figure 3.3). This was in contrast to many other I-wall sections that had either been severely distressed or failed. It appeared that the construction of the I-wall sections in this area were significantly more robust than those other sections with damage. The walls appeared to be of newer design, with concrete sections taller and uniformly thicker. No sheetpile was observed.

Figure 3.3: I-wall adjacent to the Lakefront Airport showing deep back-scour but no evidence of distress to the wall.

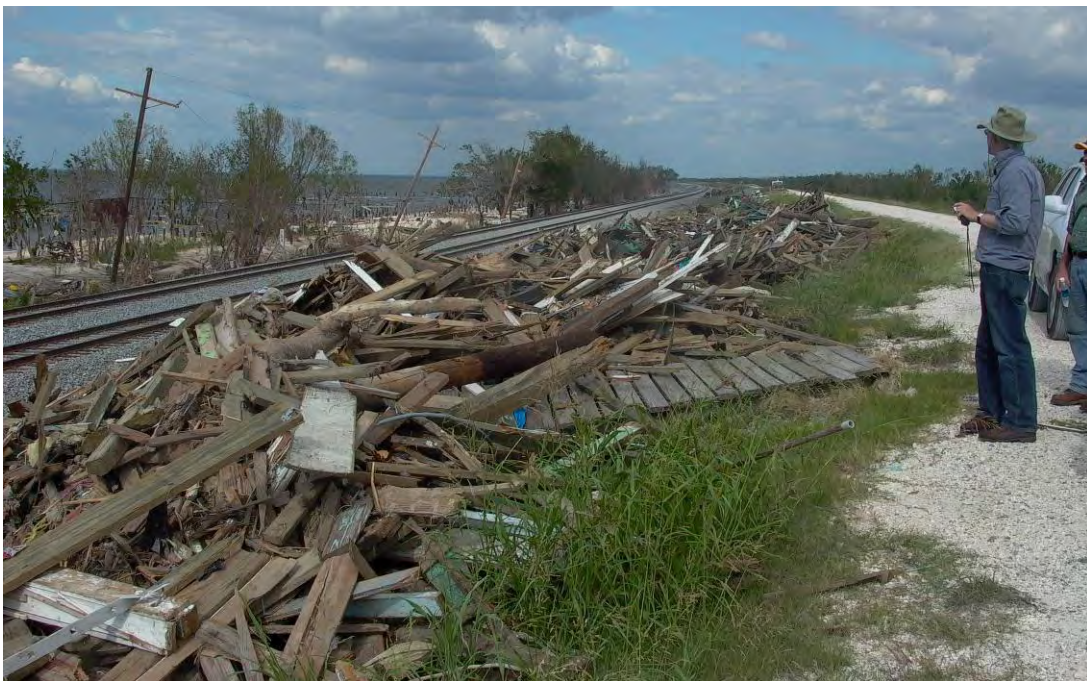
Further to the east, beyond Paris Road, the lakefront community of Little Woods was almost completely demolished by the wind and water. Figure 3.8 shows that only the pilings and some concrete stairs remain. Figure 3.9 shows debris from the demolished structures left very near the crest of the levee, indicating a high water level consistent with other water lines we observed in the lakefront area. Debris from the houses was also strewn on the landside of the levee in a pattern that suggested wind transport. Figure 3.10 shows the only surviving structure at Little Woods, which was noticeably elevated on piles. It appears intact except for the absence of stairs to reach the elevated balcony, suggesting that the building industry can deliver structures that resist storm forces like the ones experienced during Hurricane Katrina at Little Woods.

Figure 3.9: Debris from the Little Woods houses accumulated near the crest of the earth levee indicates the level of the lake waters during the storm. (Photo by F. Silva – N 30° 04' 70.5", W 89° 56' 44.0")

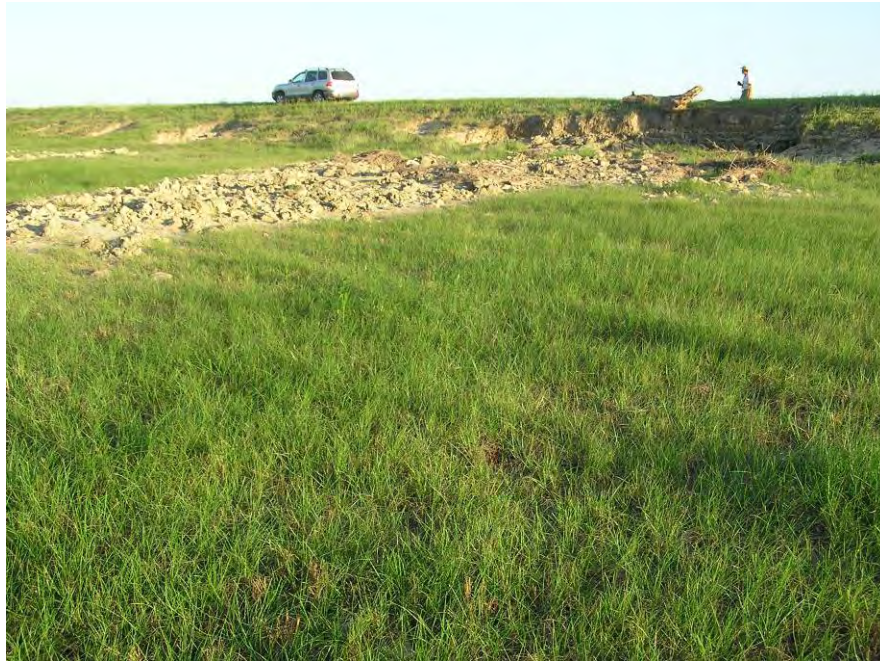
Figure 3.15: Embankment along the IW that survived although somewhat scoured.

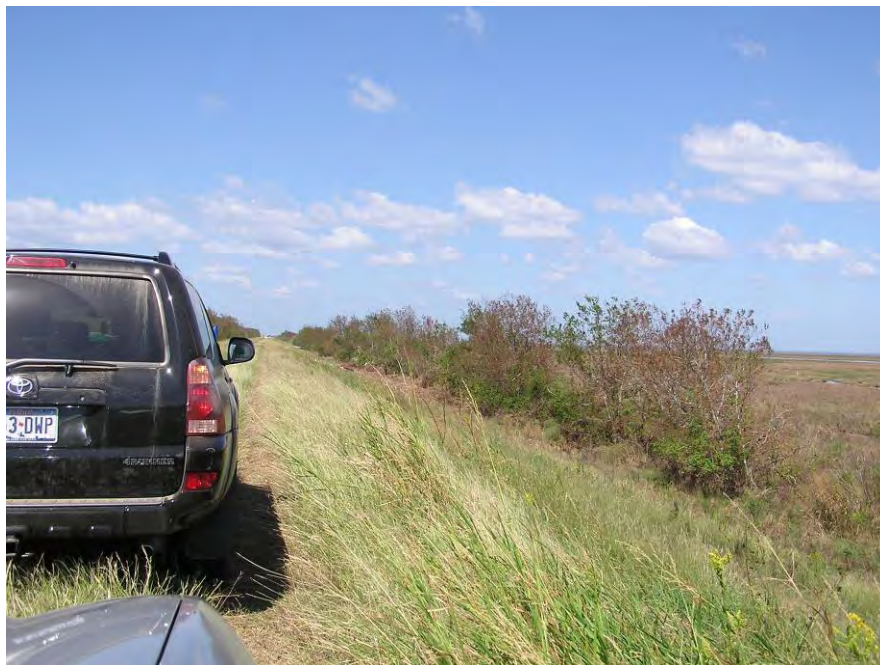
Figure 3.16: Virtually unscathed earth embankment levee on the eastern edge of the protected area of New Orleans East

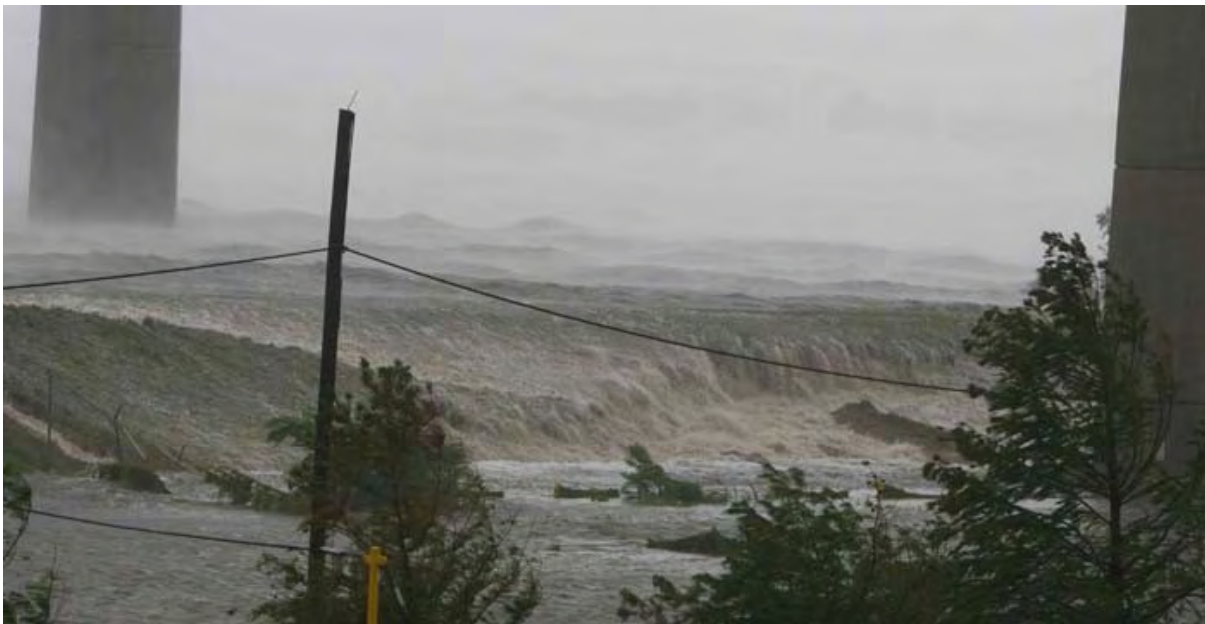
Figure 3.18: Same view of the overtopped earth embankment as seen in Figure 3.16 taken during the storm surge.

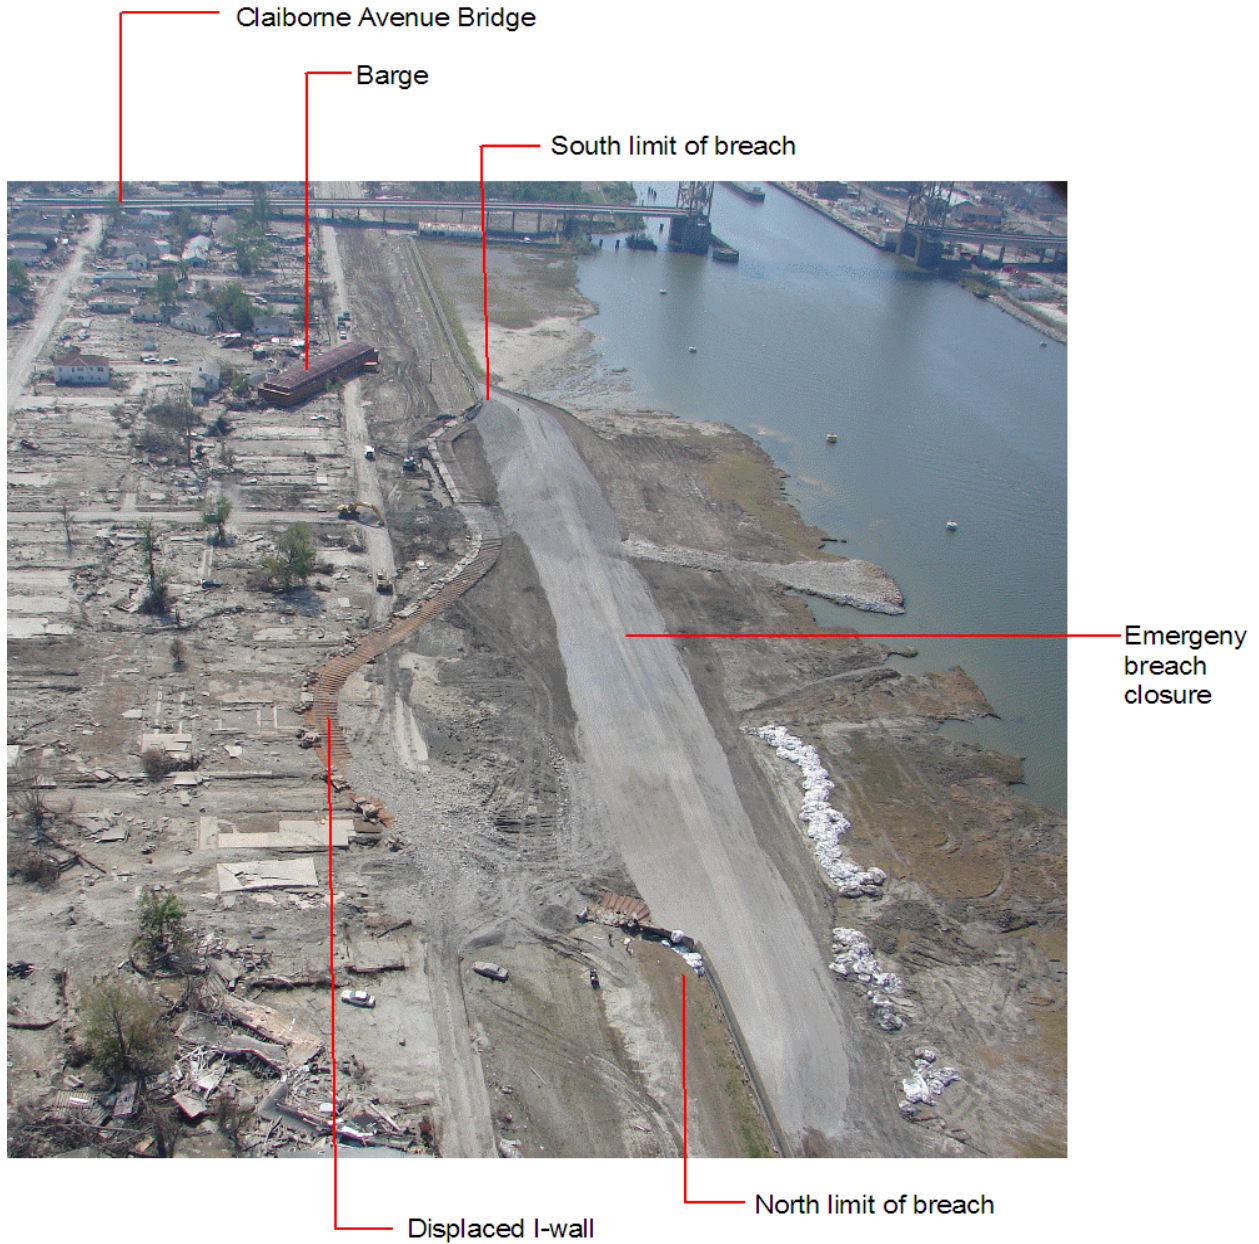
Figures 4.2 and 4.3 show aerial views of an approximately 900 ft. long levee breach located approximately 850 ft. north of the Claiborne Avenue Bridge. The breach initially resulted from the Hurricane Katrina storm surge in the IHNC. An emergency repair was made shortly after the breach occurred. This repaired portion of the breach was later overtopped on September 24 by a storm surge caused by Hurricane Rita, which flooded the Lower Ninth Ward for a second time (floodwaters reached a depth of about 3 feet). This second flooding incident was reportedly much less severe than that caused by Hurricane Katrina, and as such, it is likely that it caused relatively little, if any, additional damage to the levee system along the east side of the IHNC. The earthen portion of the levee was almost completely destroyed and the I-wall was overturned (toward the land side) and dragged inland a maximum of 187 feet. As shown in Figure 4.2, the displaced I-wall assumed a sinuous shape that reached its maximum distance along the northern extent of the breach. It is worth noting that the sheet pile remained interlocked, hence the displacement resulted from stretching of the I-wall structure. The unbreached portions of the I-wall system located immediately north and south of the failure were tilted landward, reaching their maximum inclination of approximately 3 degrees near the breach and gradually tapering to close to vertical at further distances. Scour trenches at the toe of the floodwall (protected side) were found along the entire length of the intact I-wall section. The scour trenches were typically about 5 ft. wide at the top and extended to depths of approximately 4 ft. The scour trenches were generally wide and U-shaped near the breached area and gradually became narrower, V-shaped and incised with distance from the breach (Figure 4.4).

Fig. 4.3: Airborne digital imagery of the south breach at the Lower Ninth Ward. Water is shown flowing back into the IHNC. (courtesy NOAA, August 31, 2005).

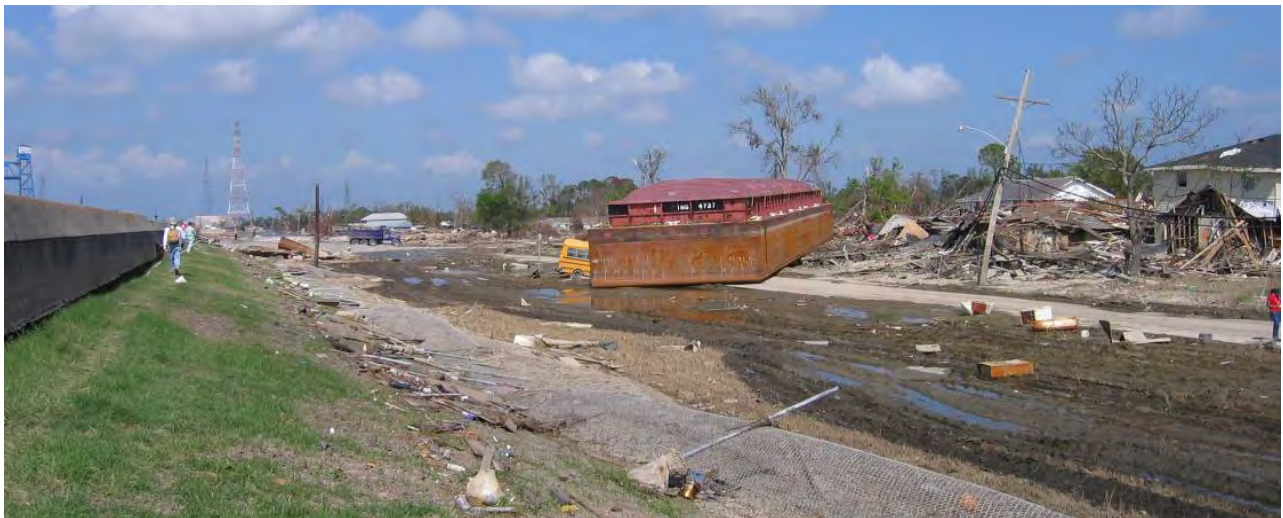
Fig. 4.6 - South view of the south breach repair at the Lower Ninth Ward (J. Wartman, October 4, 2005).
